# National Transportation Safety Board Aviation Accident Preliminary Report

<b>Location:</b>	Mokuleia, HI	<b>Accident Number:</b>	ANC20FA024
<b>Date &amp; Time:</b>	02/22/2020, 0920 HST	<b>Registration:</b>	N65070
<b>Aircraft:</b>	CESSNA 305	<b>Injuries:</b>	2 Fatal
<b>Flight Conducted Under:</b>	Part 91: General Aviation - Instructional

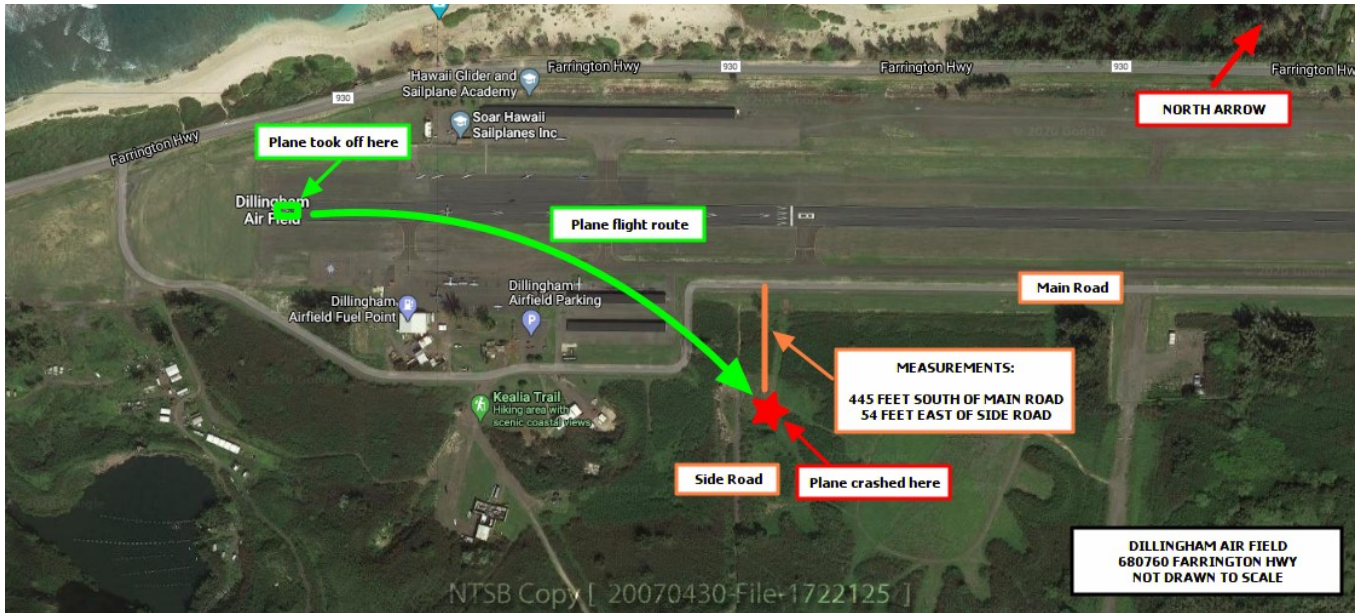
According to multiple witnesses, the airplane took off on runway 8 and completed one lap in the pattern. A witness reported that the first landing was "rough," and the tail wheel bounced up and down and the airplane came to an abrupt stop on the runway. The engine was shut down on the runway and the rear seated instructor pilot disembarked. He walked around the airplane and then stopped alongside the front seated pilot and talked to him for a while. The instructor pilot then boarded the airplane and the engine was started and the airplane took off again. Witnesses reported that after the airplane cleared the runway surface, the airplane yawed hard right and drifted south toward the tree line. A pilot who witnessed the flight stated that the airplane was "obviously in distress and not in control." Some witnesses reported the engine sound diminishing as the airplane approached the trees, and then surge again as the airplane flew over the tree line and then the engine sound went quiet. One witness saw the airplane turn right, then rapidly roll left and descend to the ground in a nose low attitude. See figure 1 for the observed flight path and impact location.

Figure 1. Observed accident flight route and impact location (Courtesy of Honolulu Police Department)

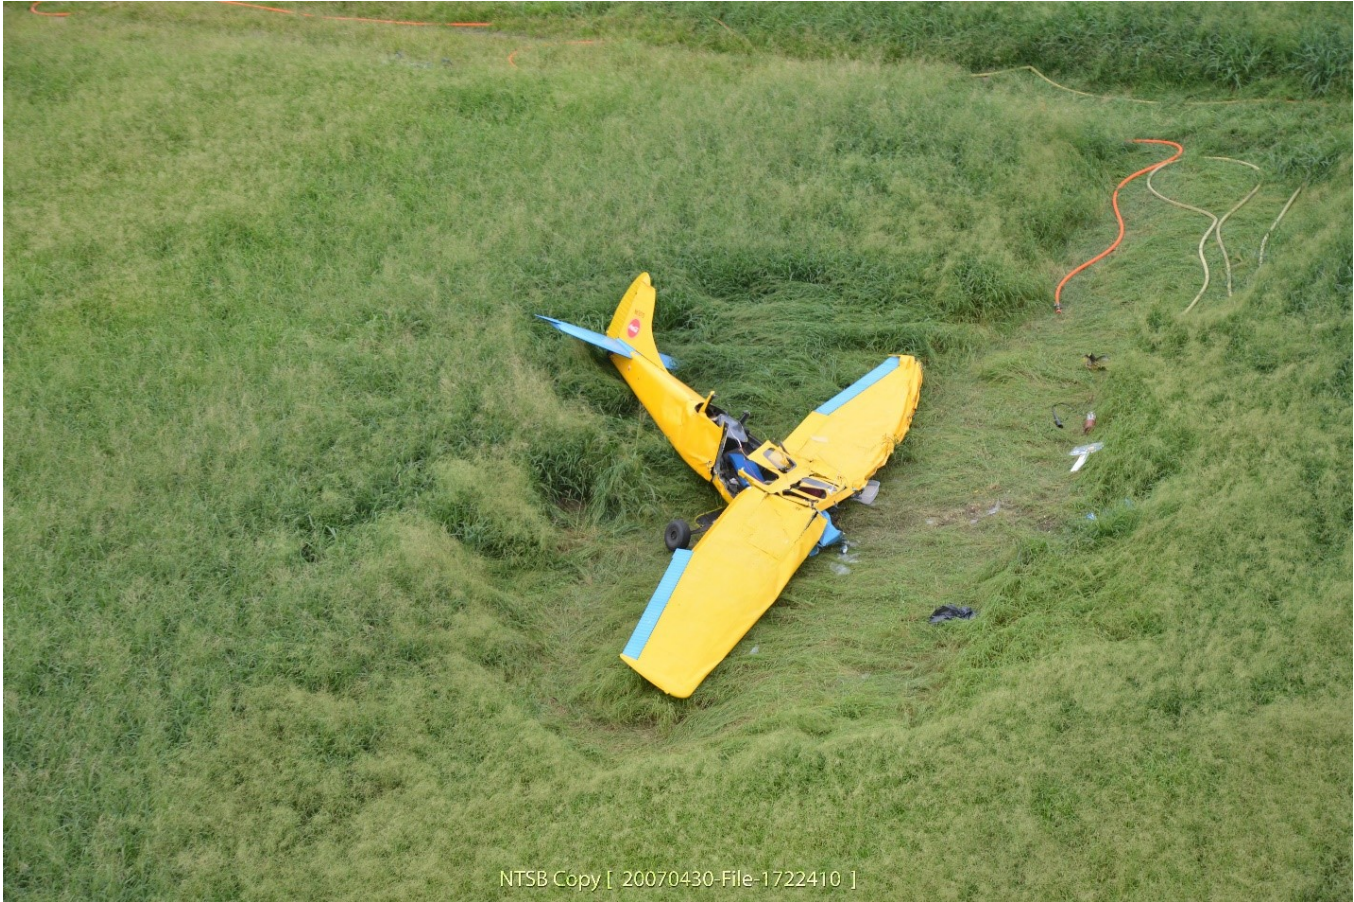
The wreckage was located in a field of long grass on US Army property about 800 ft south of the runway near an access road. The airplane came to rest slightly nose down, upright on the fuselage in a left wing down attitude heading about 100°. The forward fuselage and left wing leading edge sustained substantial damage. The propeller was separated from the engine and located in a 6 inch depression about 4 ft in front of the wreckage. The fuselage exhibited buckling on the left side mid-section. Fuel leaks were evident at the left wing tank and fuel was present in the right wing fuel tank. All major components were located at the scene. See figure 2.

Figure 2. Aerial view of N65070 wreckage (Courtesy of Honolulu Police Department)
